2012 Annual Inspection and Maintenance Report for North Maybe Mine - East Mill Creek Restored Sediment Control Structure

Submitted by:
Nu-West Industries, Inc. and Nu-West Mining, Inc.

Submitted to:
United States Department of Agriculture, Forest Service

December 2012

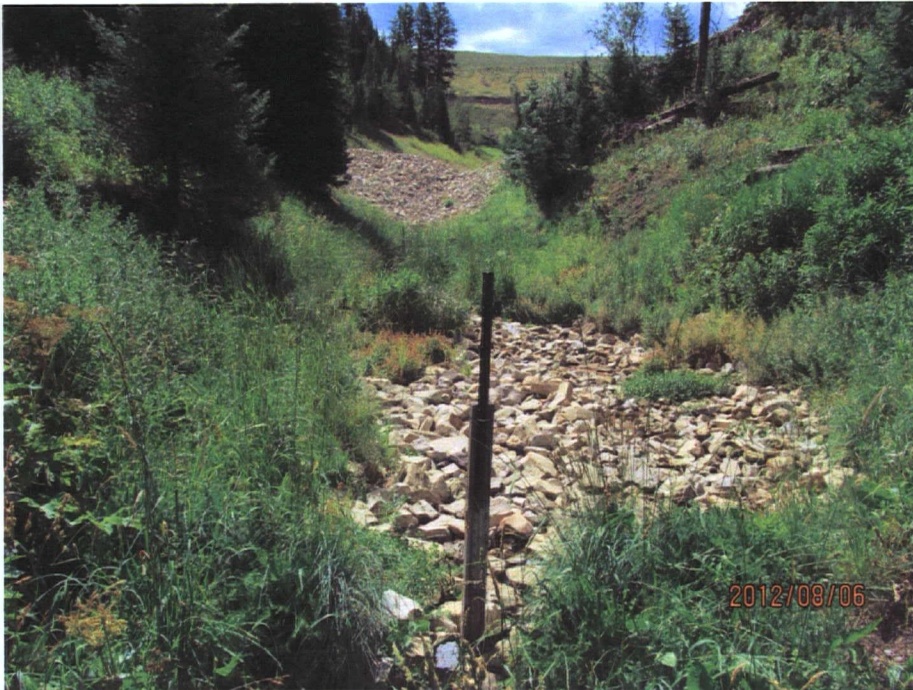
Photo taken looking south, showing the riprap lined channel below the sediment control structure and the lower weir.

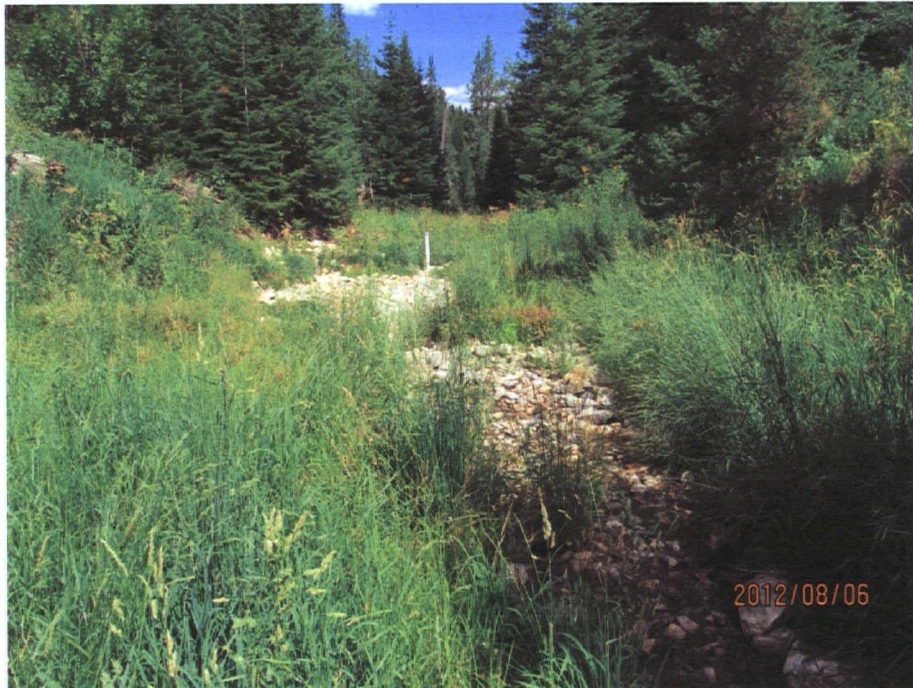
Photo taken looking north, showing the riprap lined channel below lower weir. This area is stable with a good establishment of vegetation.

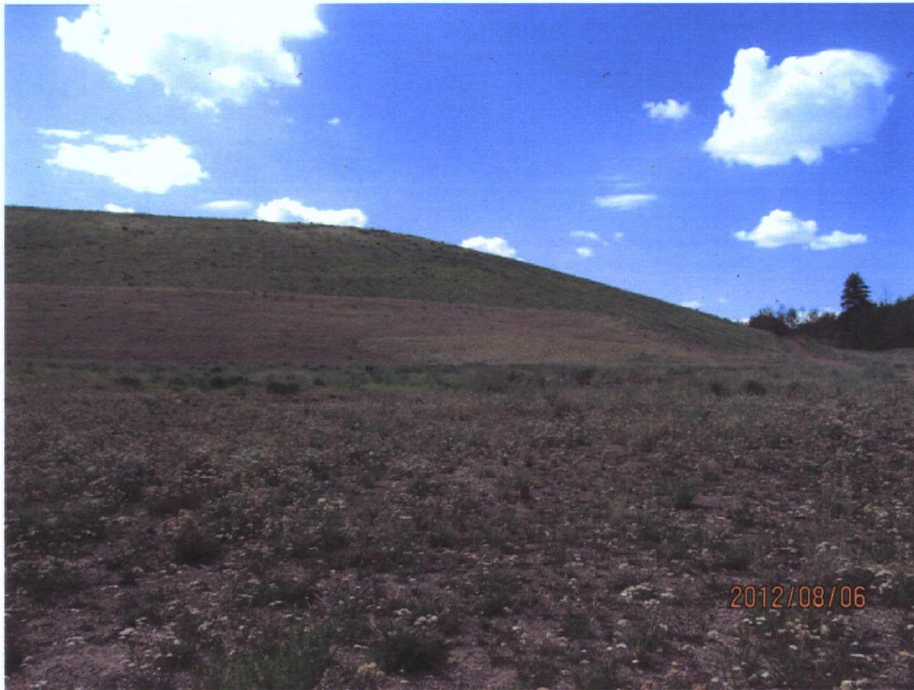
Photo taken looking south, showing the waste consolidation area. Vegetation has established.

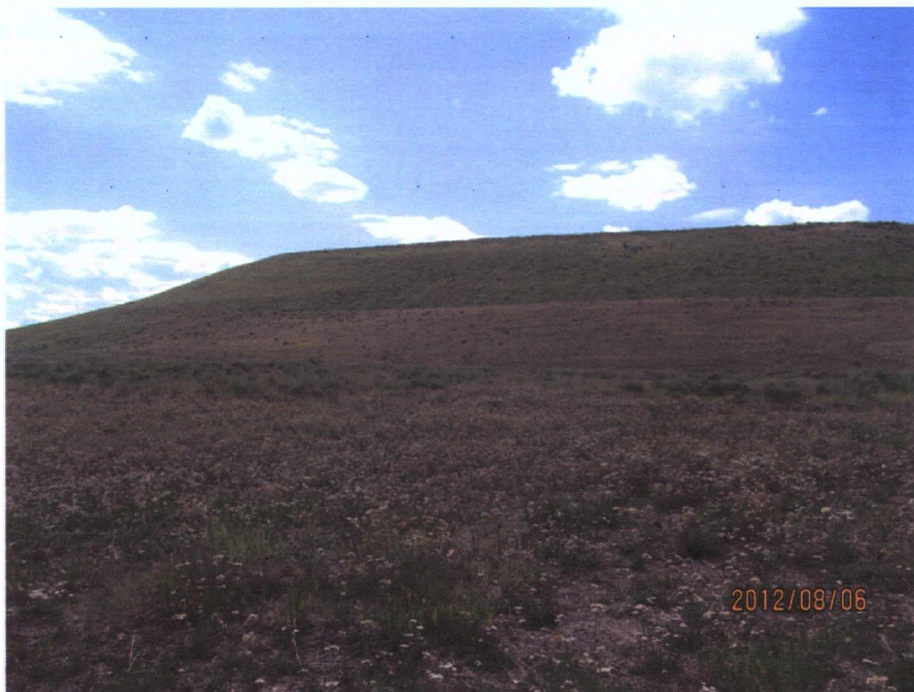
Photo taken looking southeast, showing the waste consolidation area.

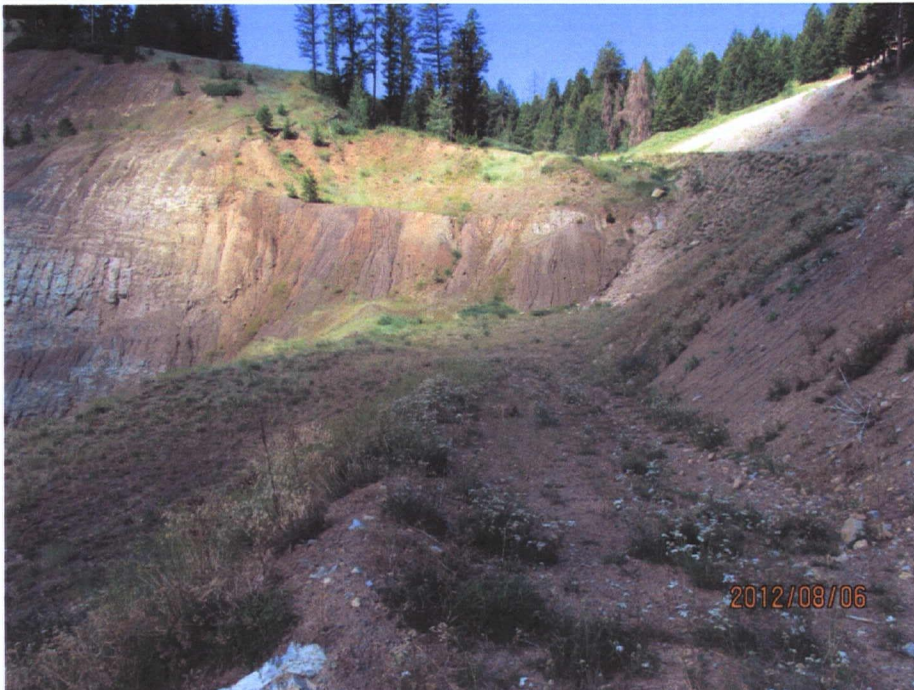
Photo taken looking west, showing the growth media borrow area located at the north end of the pit. This area is holding up well showing no signs of erosion and vegetation becoming established.

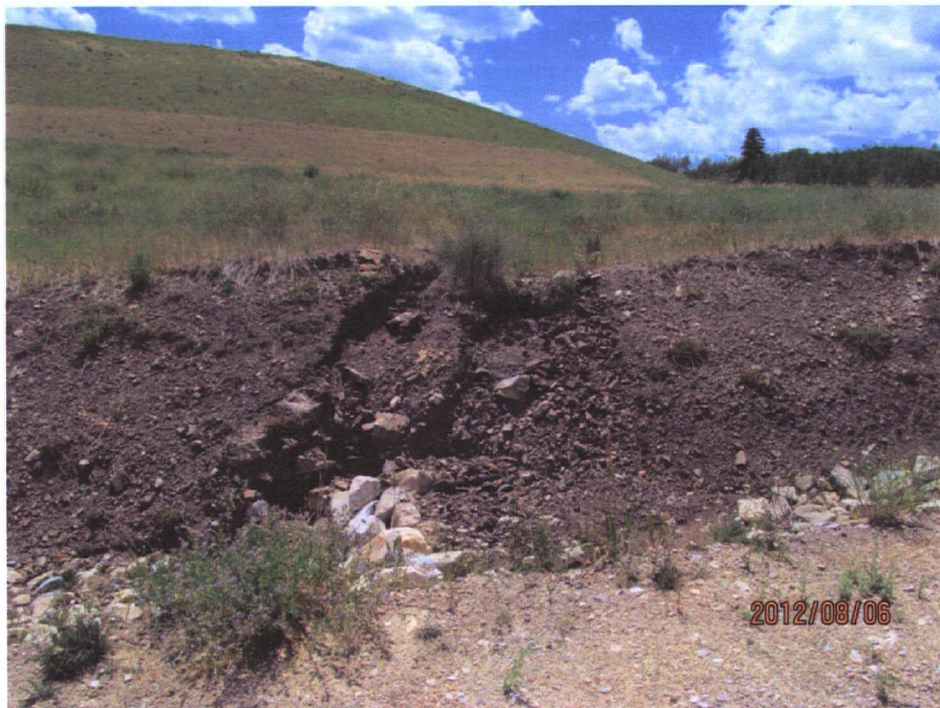
Storm water runoff from a recent storm event (likely the July 7 event) concentrated in the area immediately below the soil consolidation area on West Mill Dump and formed a rill at the point where it flows down into the access road ditch. Additionally, the storm water scoured the access roadside ditch causing many of the sediment traps to fill, or partially fill, with sediment. The immediate TCRA area (toe berm, sediment pond, etc.) were not adversely affected by the storm. The rill was repaired and armored, maintenance was performed to the roadside ditch and the roadside sediment traps were cleaned out in October. A corrective action log and photos of the maintenance are presented in Appendix B. The inspection forms and photos are presented in Appendix A.

Photo taken looking south, showing an erosion rill that formed from water running off the area below the waste consolidation area.

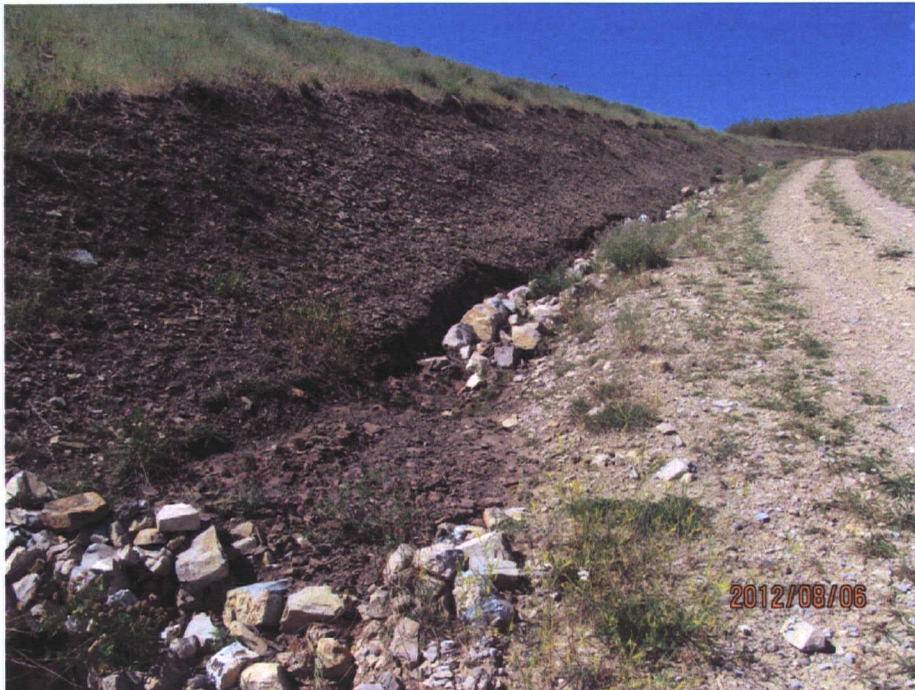
Photo taken looking west, showing the upper portion of the access road. Ditch experienced some erosion and scouring from a recent storm event.

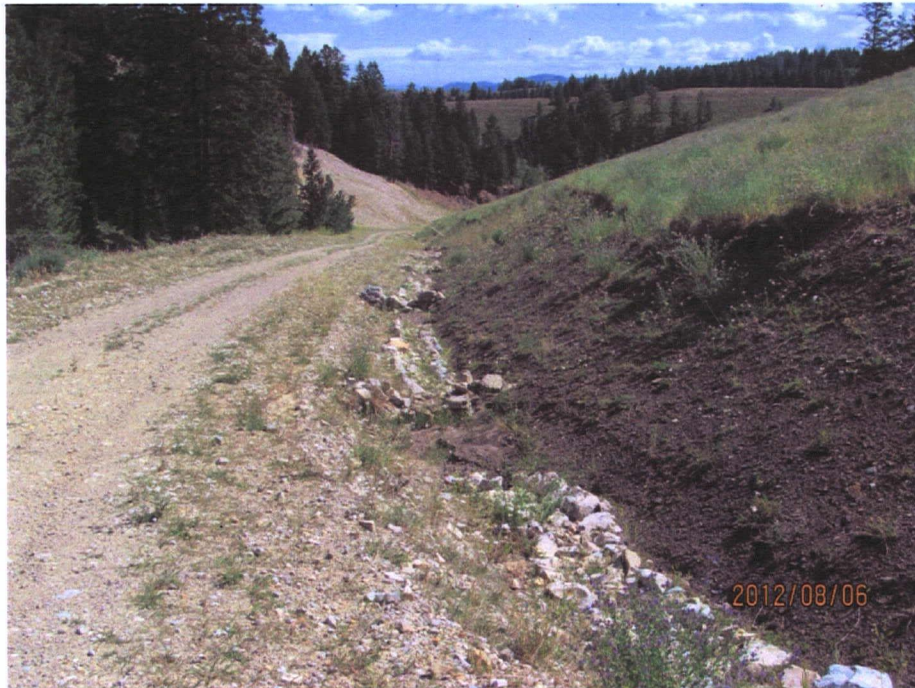
Photo taken looking east, showing the upper portion of the access road. Ditch experienced some erosion and scouring from a recent storm event.

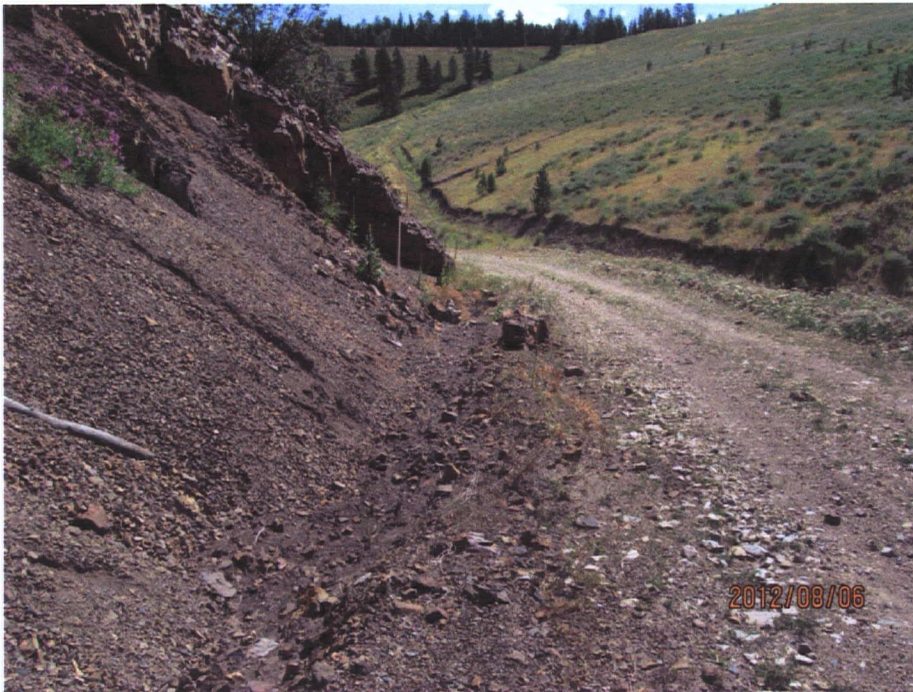
Photo taken looking east, showing the middle portion of the access road – along the north end of the North Maybe Pit. Ditch experienced some erosion and scouring from a recent storm event.

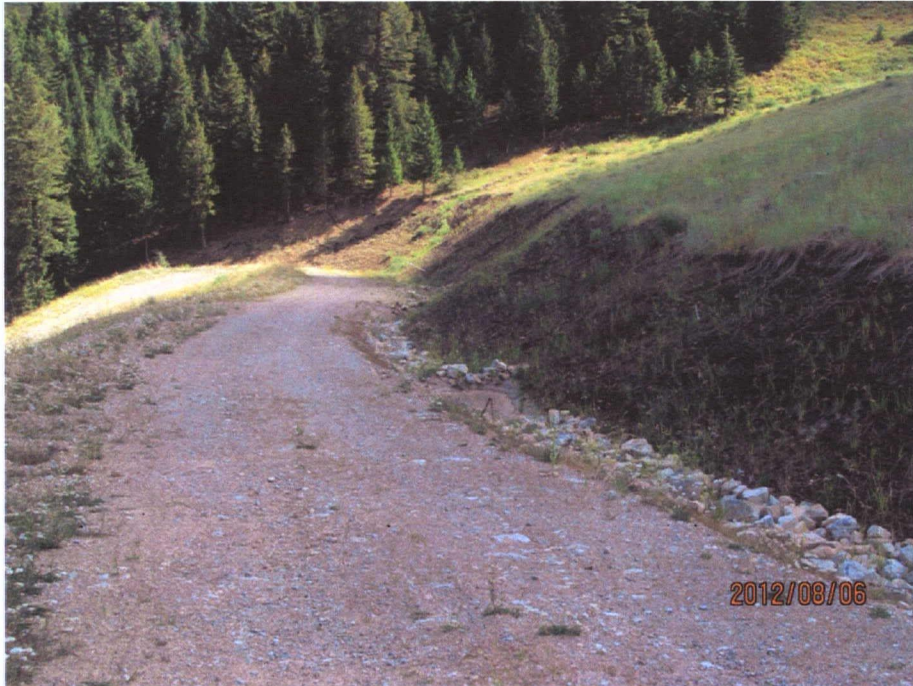
Photo taken looking east, showing the lower portion of the access road. Ditch experienced some erosion and scouring from a recent storm event.

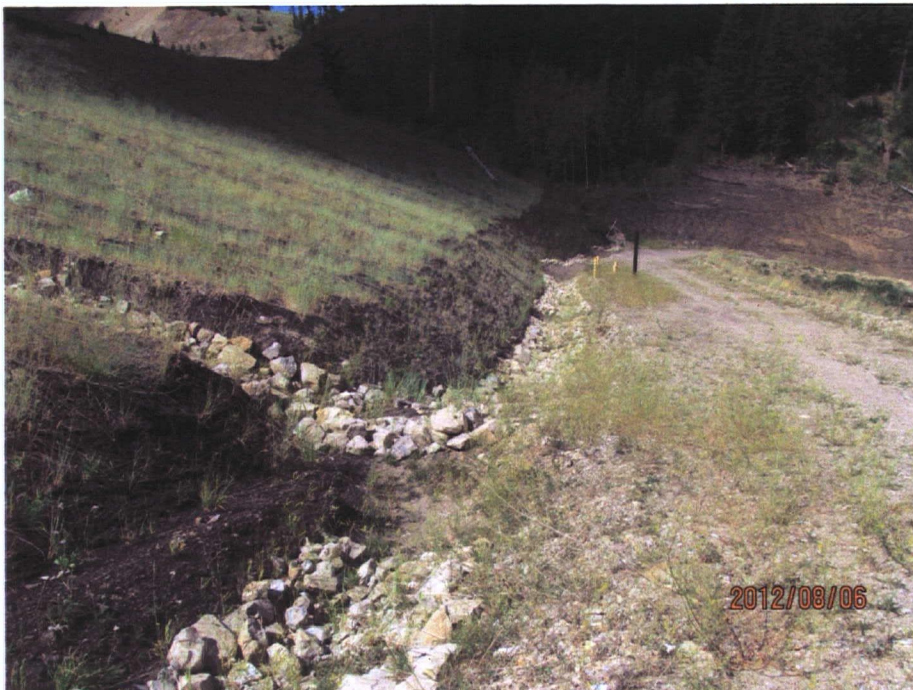
Photo taken looking west, showing the lower portion of the access road. Ditch experienced some minor erosion and scouring from a recent storm event.

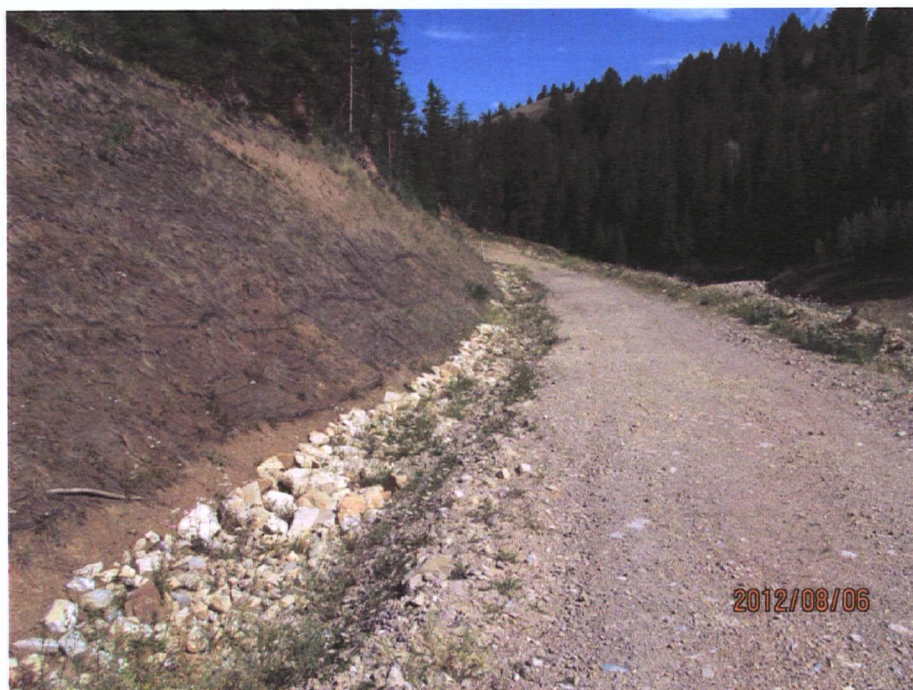
Photo taken looking west, showing the lower portion of the access road. Road and ditch are in good condition with no signs of erosion.

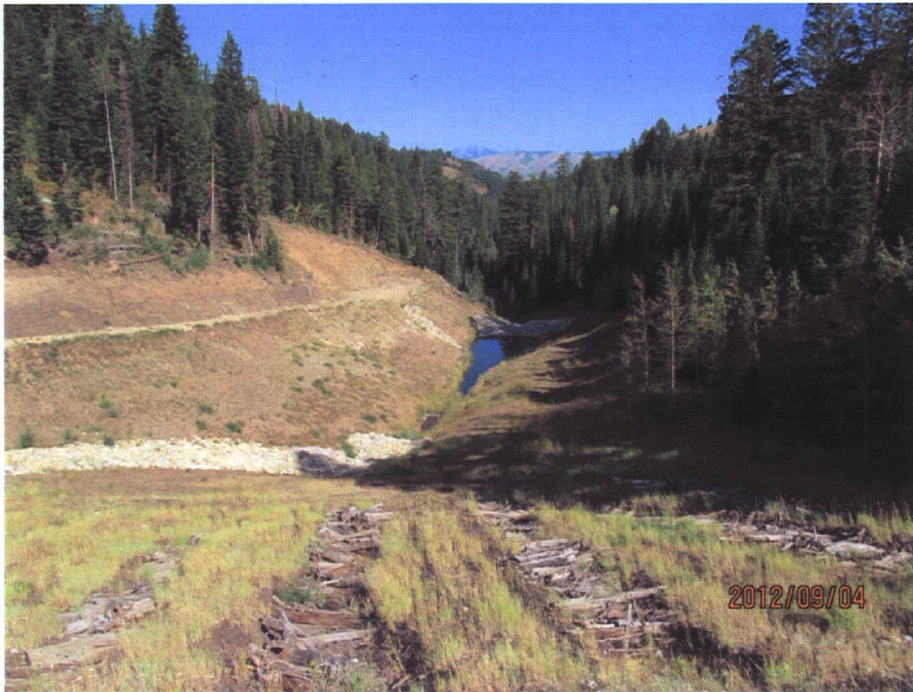
Photo taken looking north, showing the graded area surrounding the sediment pond, riprap below culvert outfalls, riprap energy dissipater, riprap toe berm, logs placed in rills on East Mill Dump and the sediment control structure.

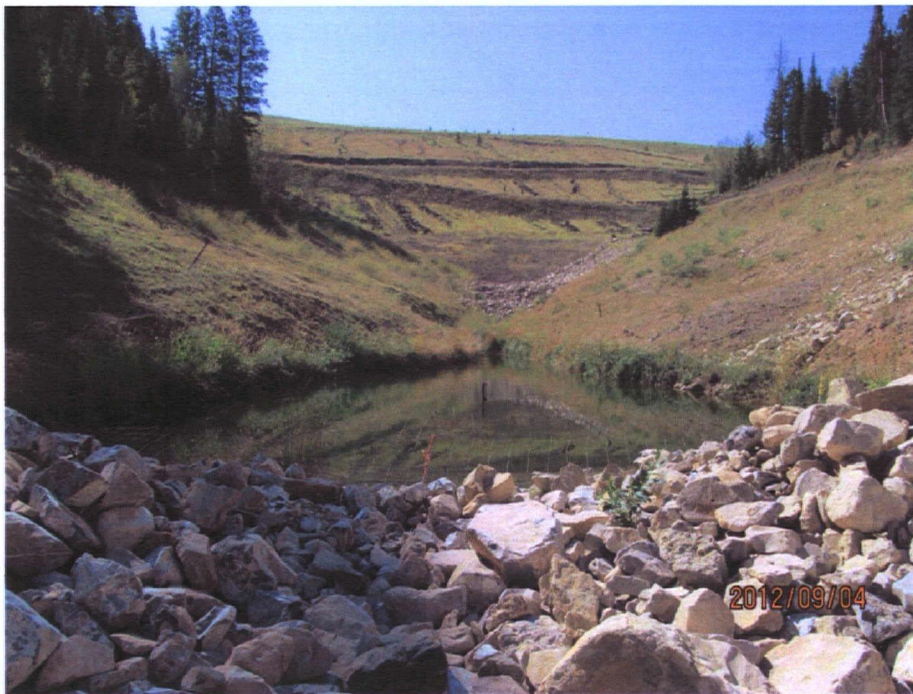
Photo taken looking south, showing the graded area surrounding the sediment pond, riprap below culvert outfalls, riprap energy dissipater, riprap toe berm, logs placed in rills on East Mill Dump and the sediment control structure.

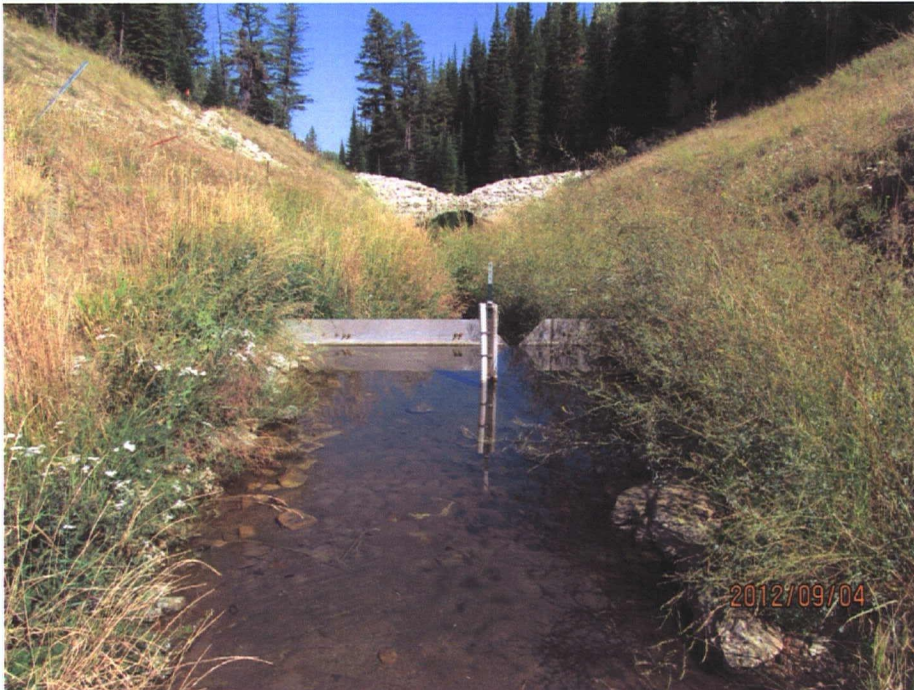
Photo taken looking north, showing the upper weir and the sediment control pond and structure. This photo shows the vegetation is well established and that the channel is in good condition.

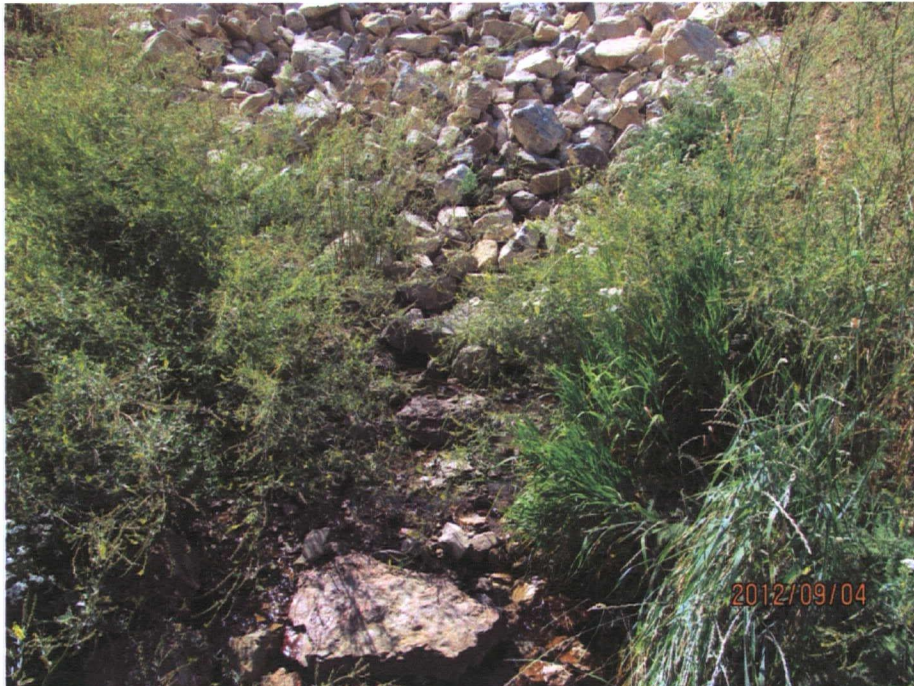
This photo is the toe of the riprap energy dissipater. Riprap armor is holding up well and there is abundant vegetation.

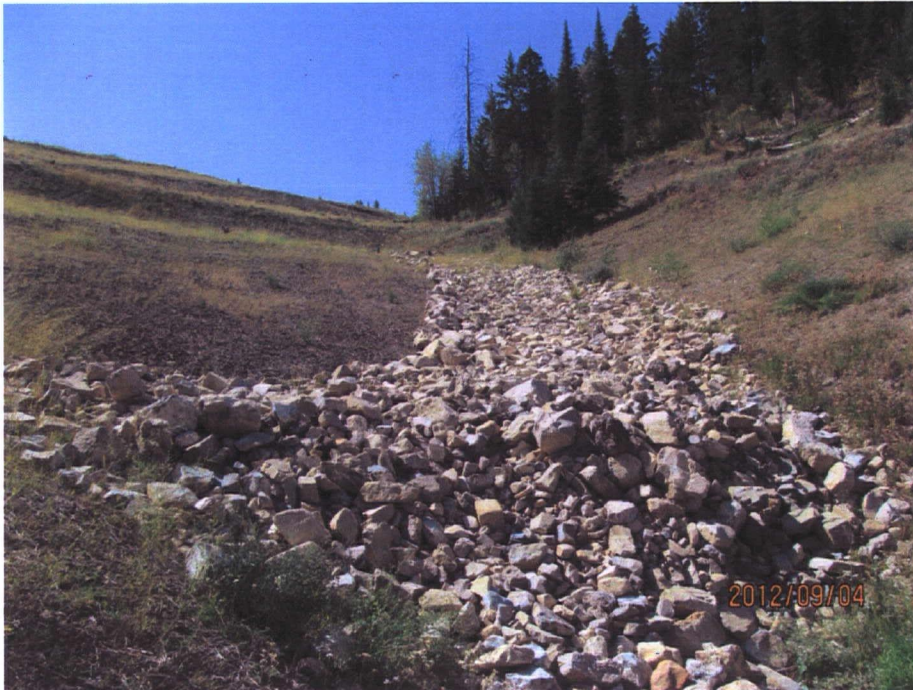
Photo taken looking south, showing the riprap lined channel below the upper culvert outfall. No sign of erosion is present.

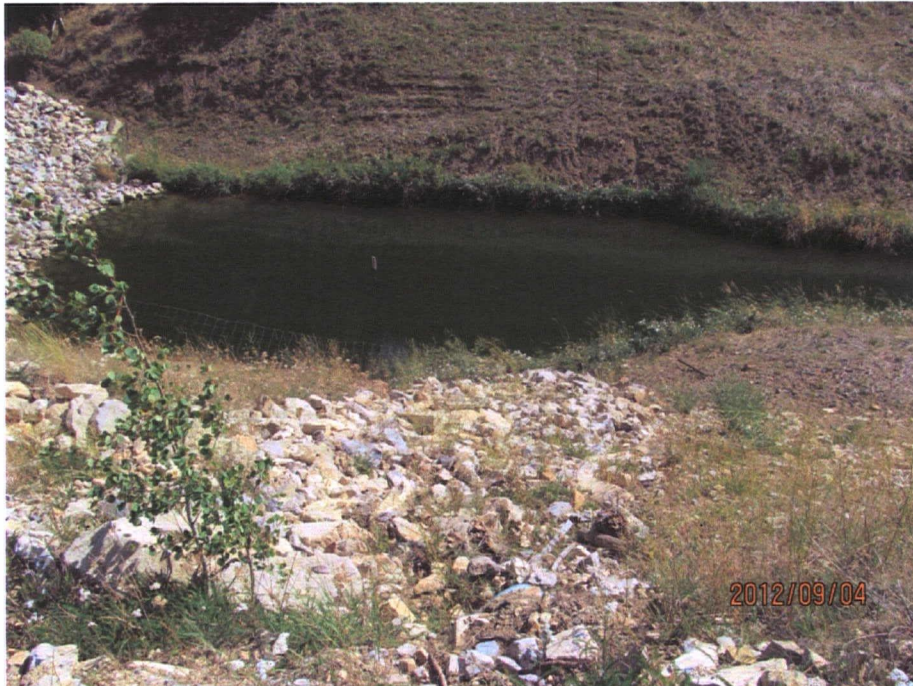
Photo taken looking east, showing the lower culvert outfall riprap lined channel and the clarity of the sediment pond.

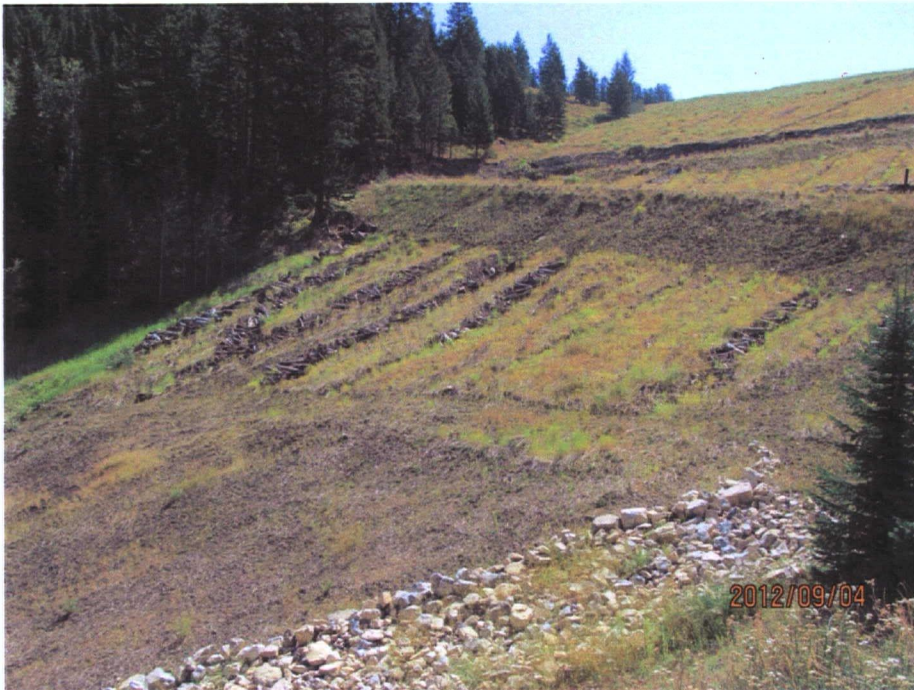
Photo taken looking southeast showing the logs in the rills on East Mill Dump and the riprap lined channel below the upper culvert outfall. No evidence of erosion is present.

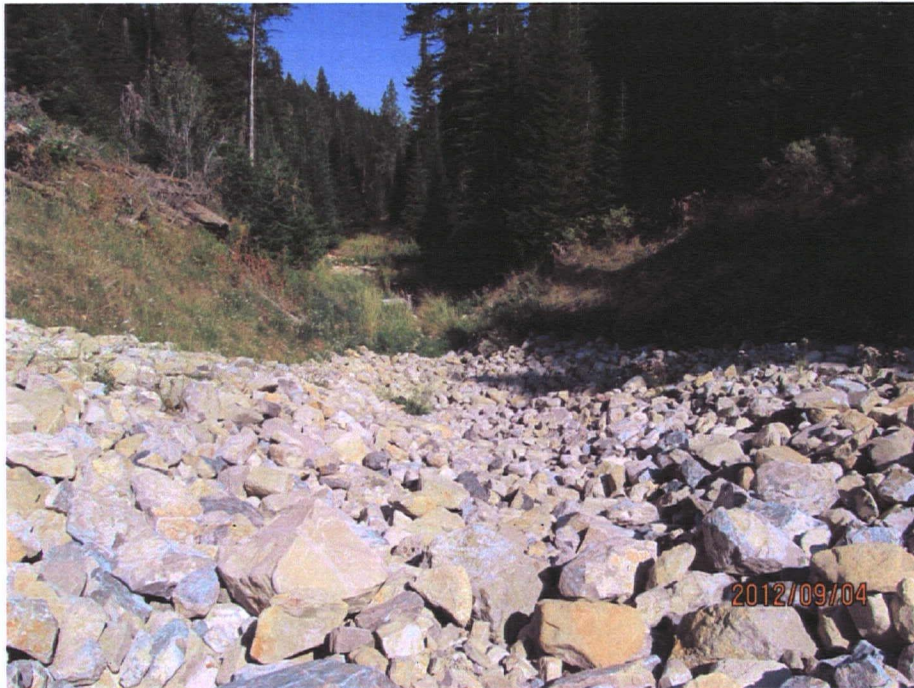
Photo taken looking north, from the top of the sediment control structure showing the lower weir and riprap lined channel below the sediment control structure.

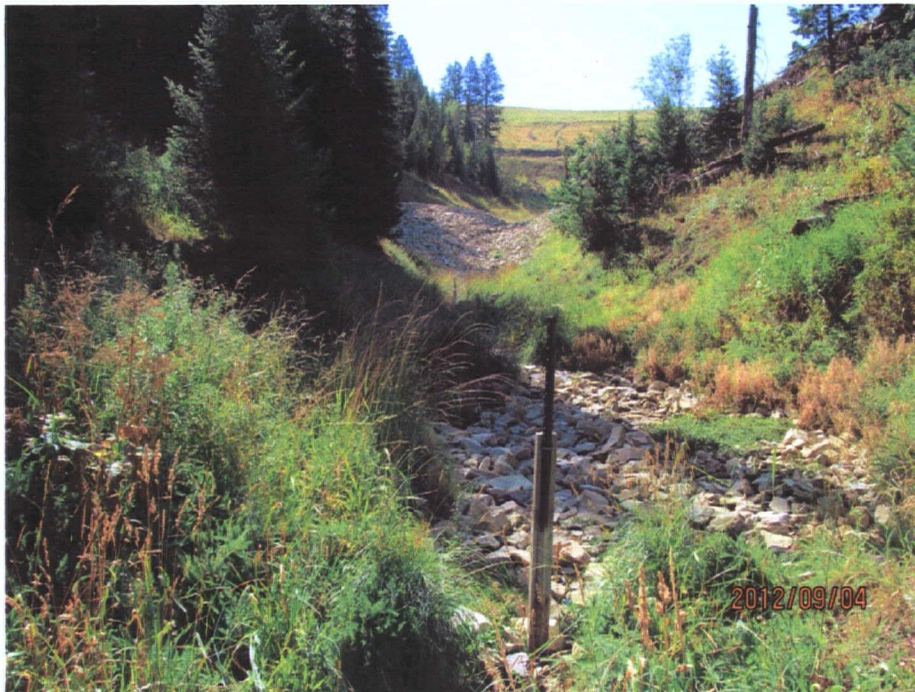
Photo taken looking south, showing the riprap lined channel below the sediment control structure and the lower weir. Abundant vegetation has established and this area is in good condition.

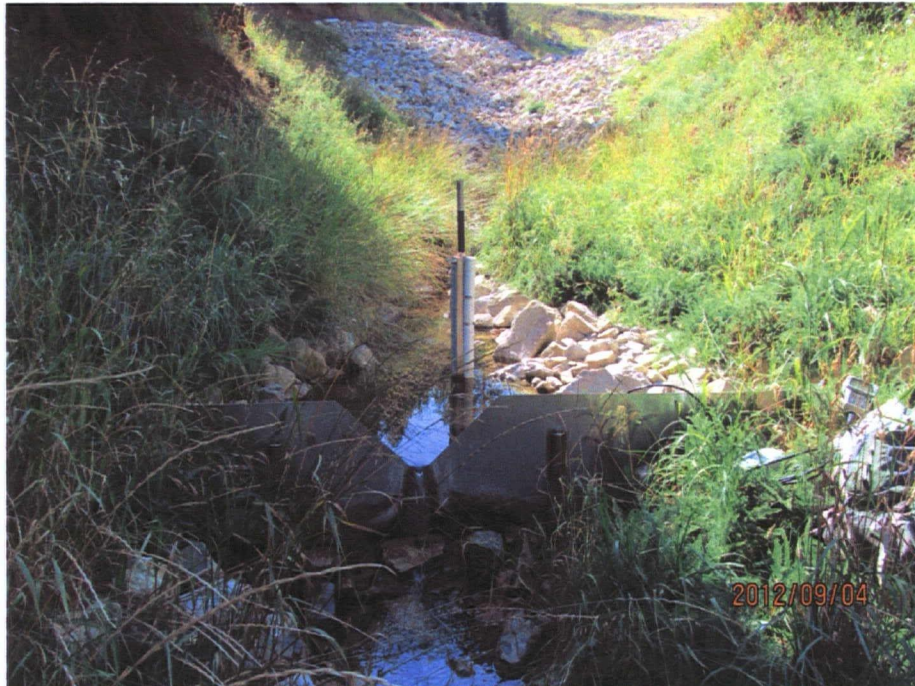
Photo taken looking south, showing the riprap lined channel below the sediment control structure and a close-up of the lower weir. Abundant vegetation has established and this area is in good condition.

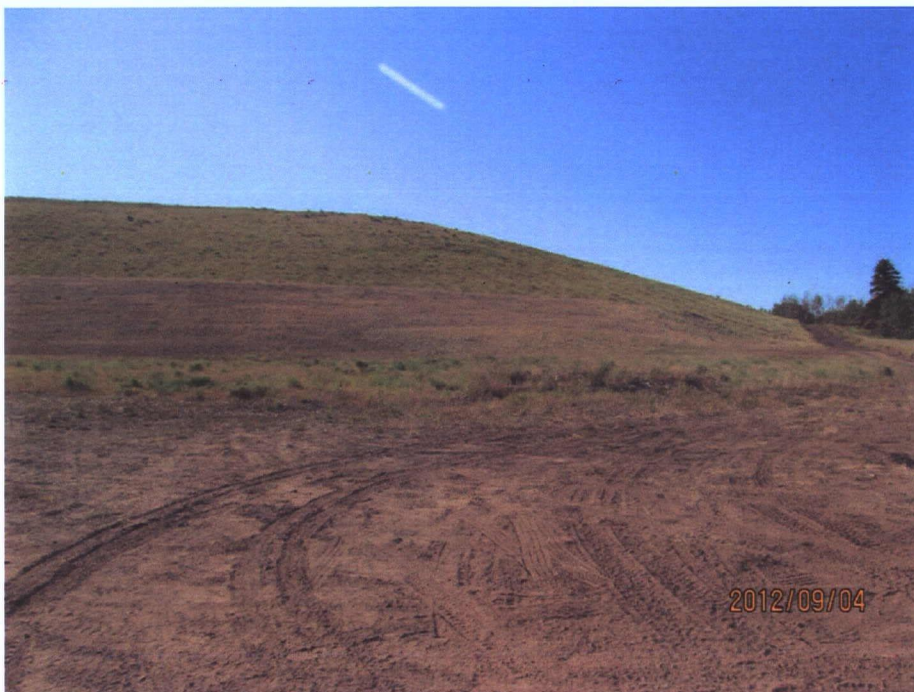
Photo taken looking south, showing the waste consolidation area. The area at the toe of the waste consolidation area is being utilized by the North Dry Ridge exploration drilling crews.

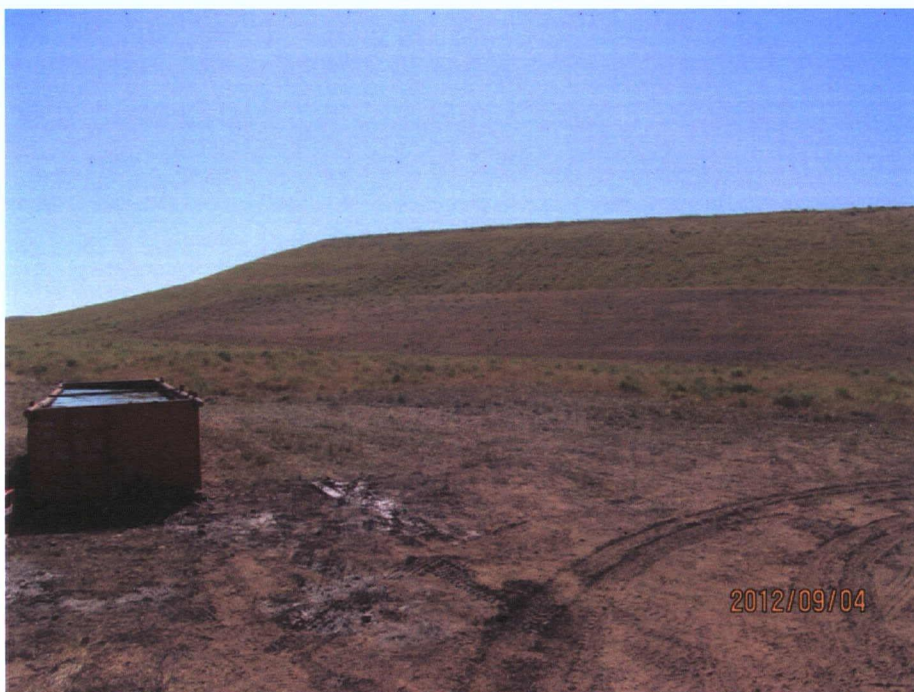
Photo taken looking southeast, showing the waste consolidation area. The area at the toe of the waste consolidation area is being utilized by the North Dry Ridge exploration drilling crews.

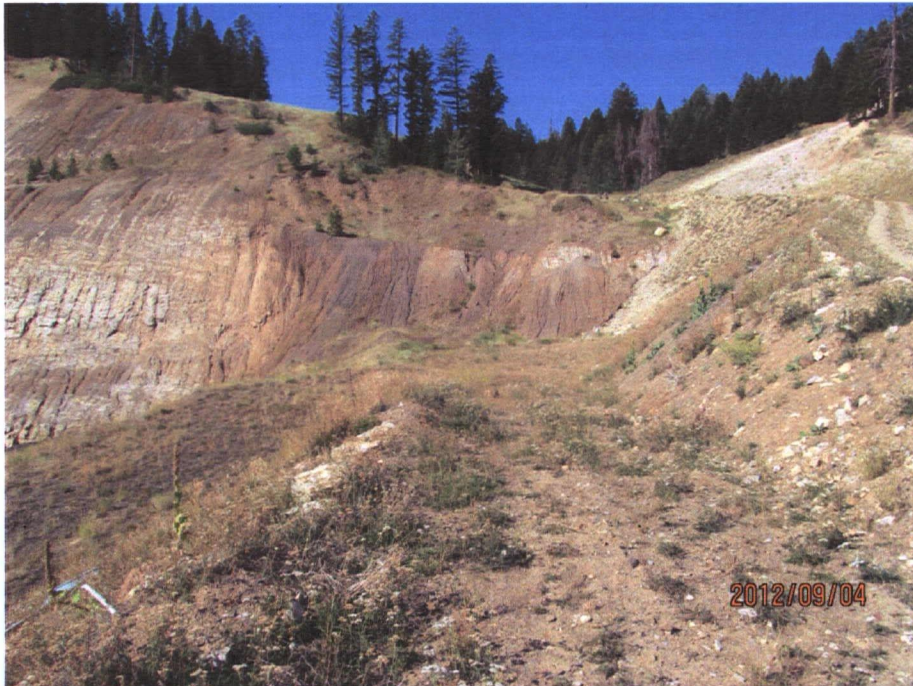
Photo taken looking west, showing the growth media borrow area located at the north end of the pit. This area is holding up well showing no signs of erosion and vegetation becoming established.

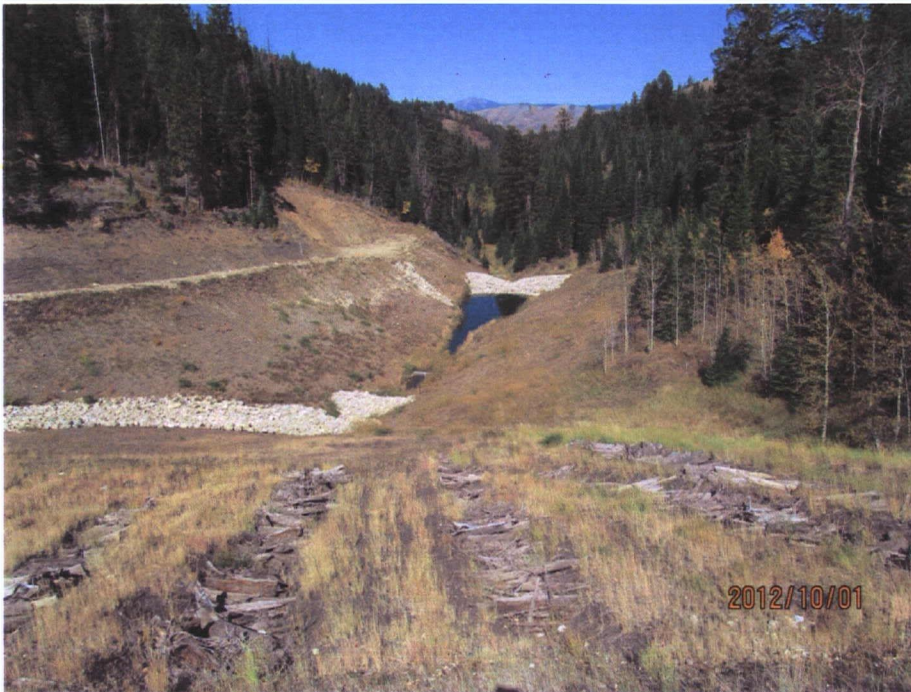
Photo taken looking north, showing the graded area surrounding the sediment pond, riprap below culvert outfalls, riprap energy dissipater, riprap toe berm, logs placed in rills on East Mill Dump and the sediment control structure.

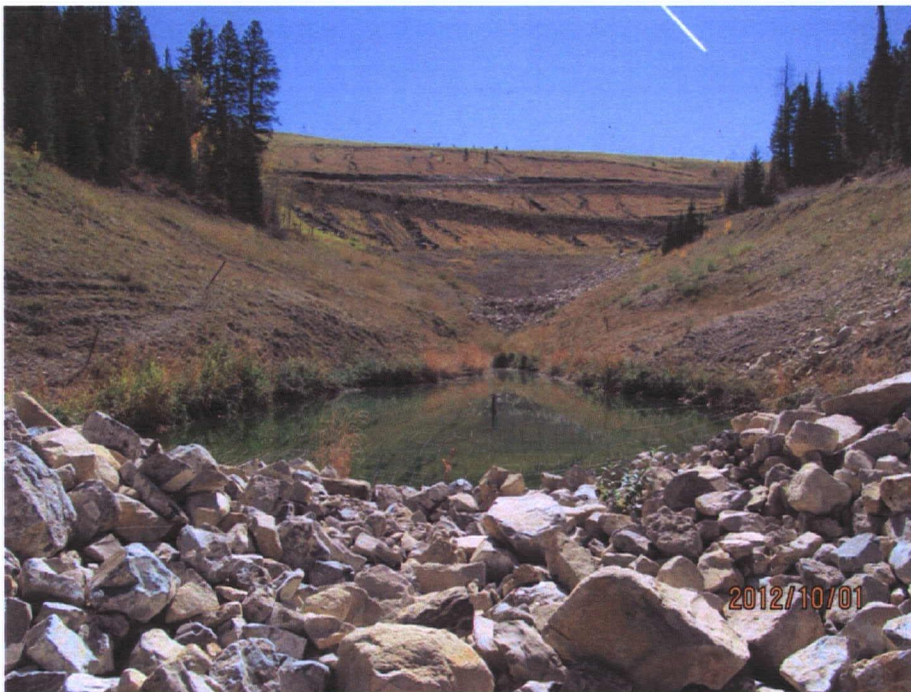
Photo taken looking south, showing the graded area surrounding the sediment pond, riprap below culvert outfalls, riprap energy dissipater, riprap toe berm, logs placed in rills on East Mill Dump and the sediment control structure.

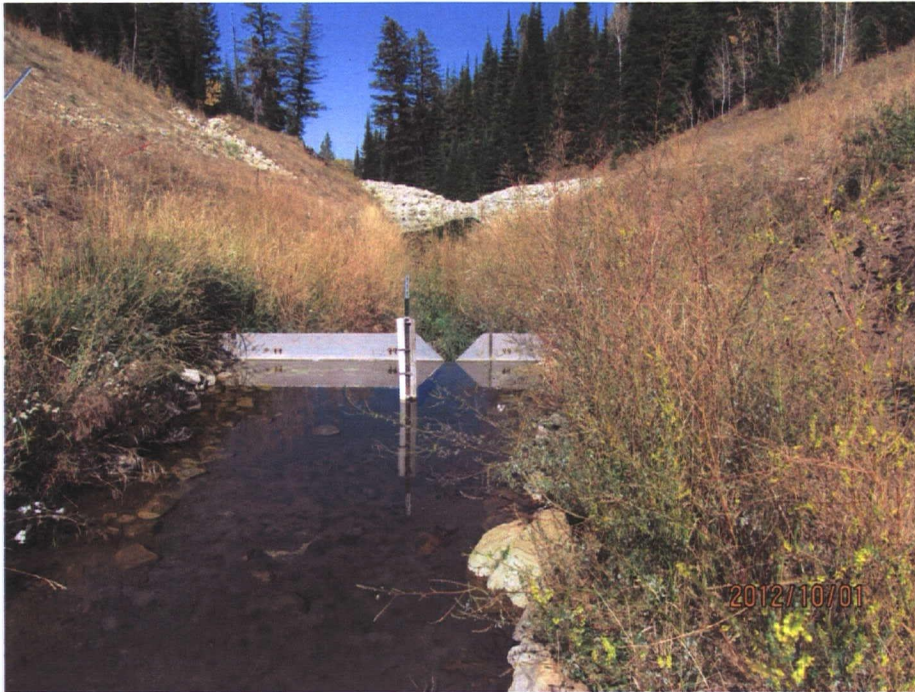
Photo taken looking north, showing the upper weir and the sediment control pond and structure. This photo shows vegetation establishment and that the channel is in good condition.

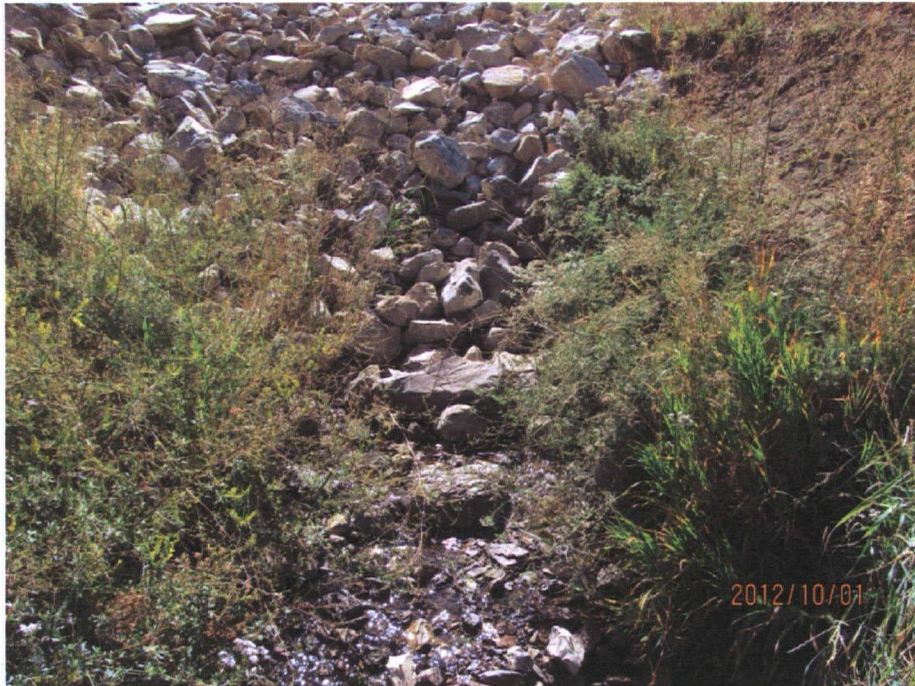
This photo is the toe of the riprap energy dissipater. Riprap armor is holding up well.

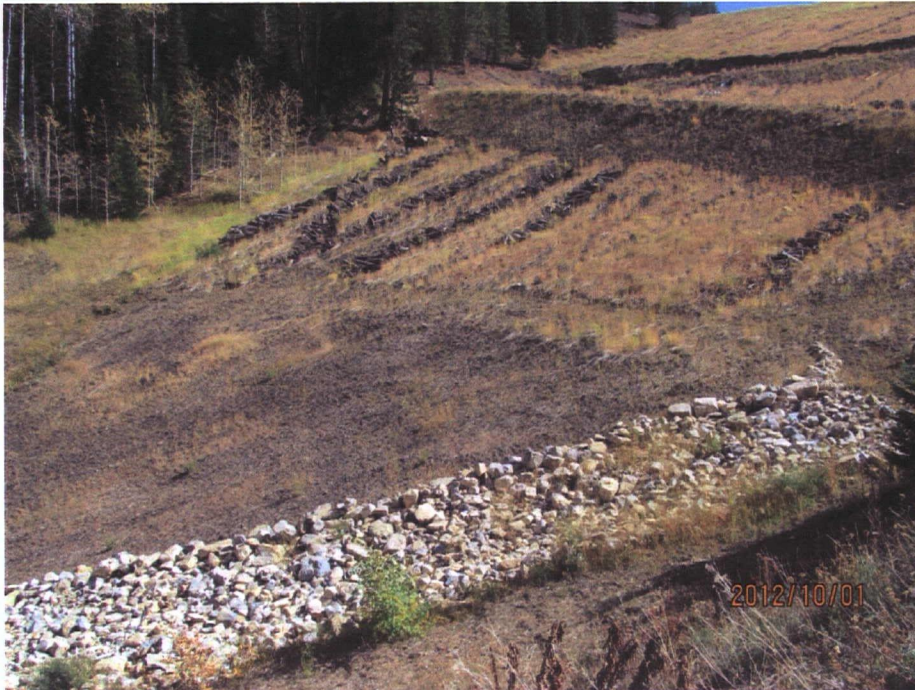
Photo taken looking southeast, showing the riprap lined channel below the upper culvert outfall and logs in Rills on East Mill Dump. No sign of erosion is present.

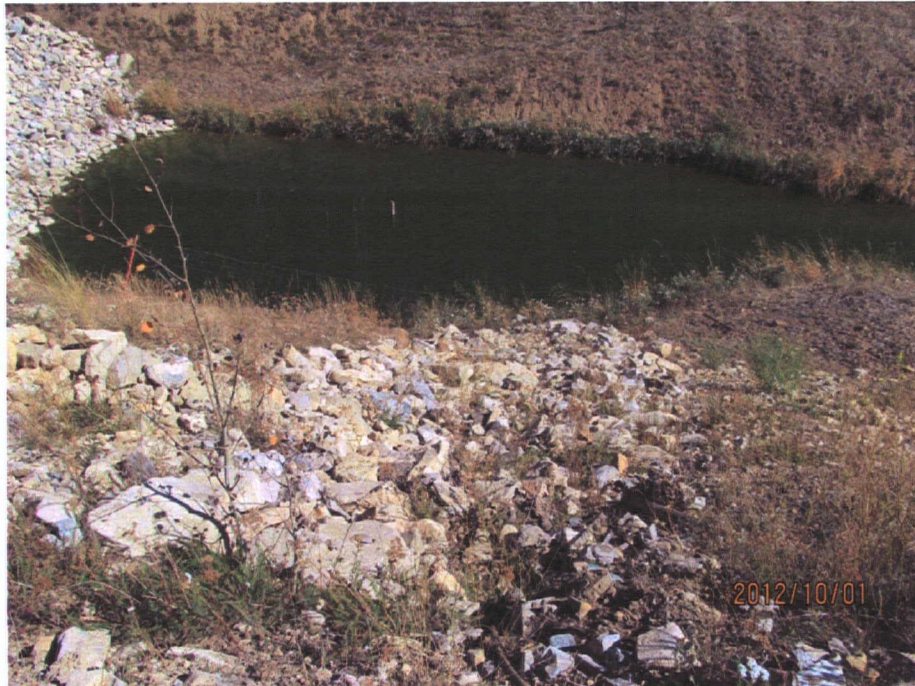
Photo taken looking east, showing the lower culvert riprap lined outfall and clarity of the sediment control pond.

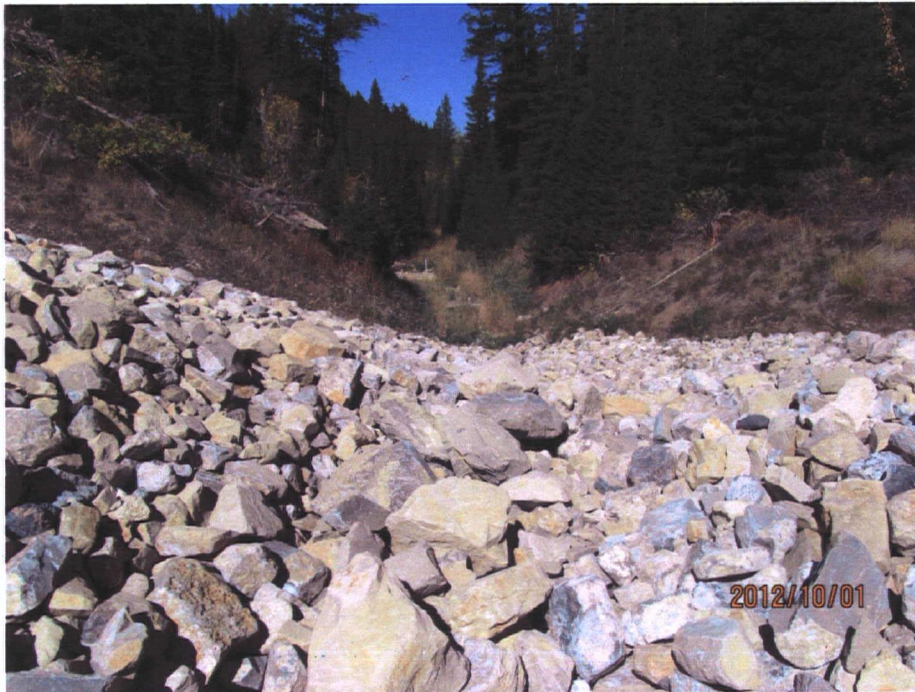
Photo taken looking north, from the top of the sediment control structure showing the lower weir and riprap lined channel below the sediment control structure.

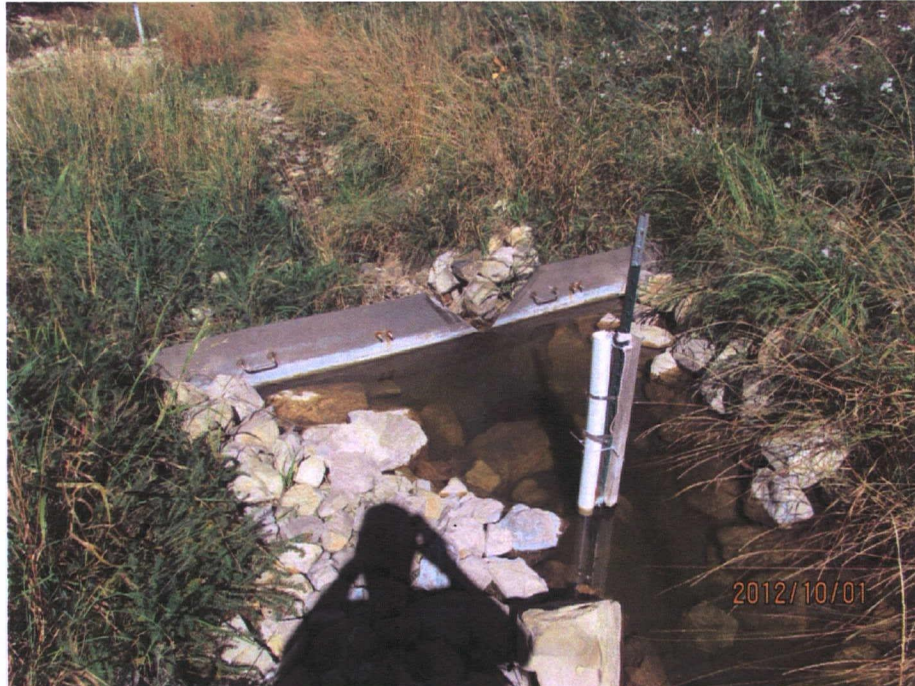
Photo taken looking north, showing a close up of the lower weir and riprap lined channel below the sediment control structure. This area is in good condition with vigorous vegetation established on side-slopes.

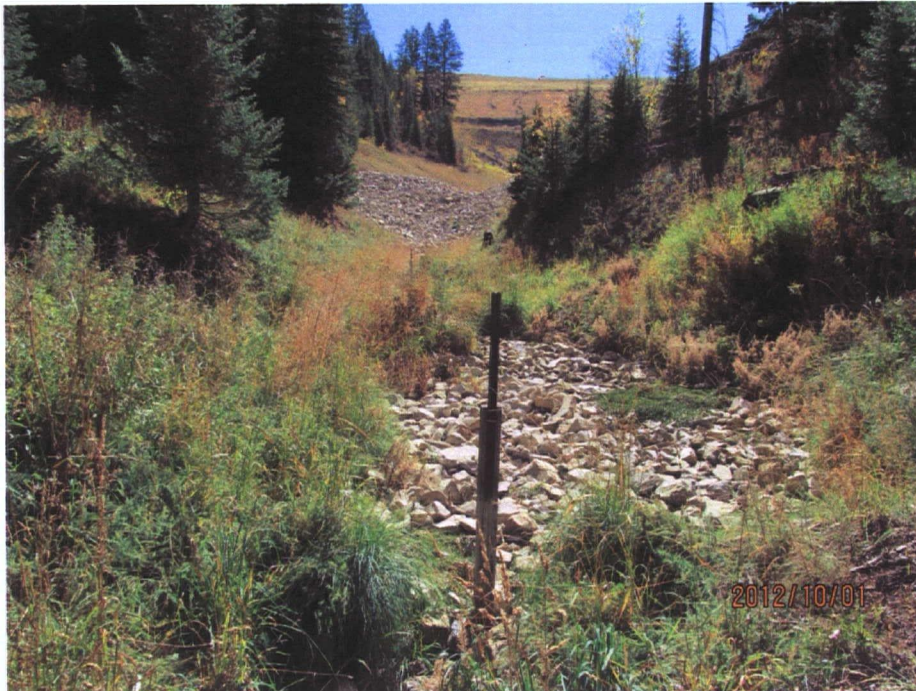
Photo taken looking south, showing the riprap lined channel below the sediment control structure and the lower weir.
